Home Builder & Development Name.

Snag Pro Scotland

# Inspection Details

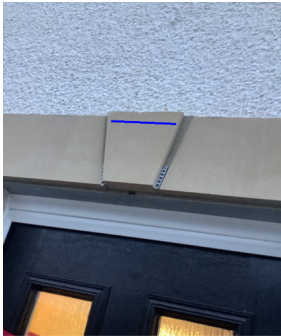
### Defect 1

Priority: Medium  
Location: Front elevation

Description  
Precast chipped

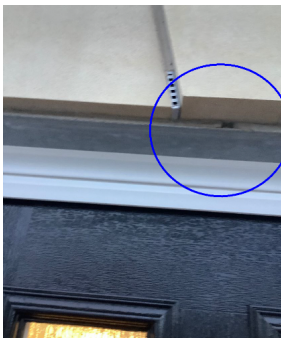
### Defect 2

Priority: Medium  
Location: Front elevation

Description  
Hungry joints at lintel

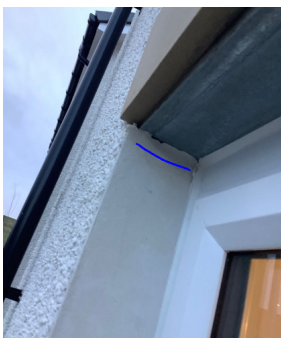
### Defect 3

Priority: Medium  
Location: Front elevation

Description  
Ingos not fully sealed

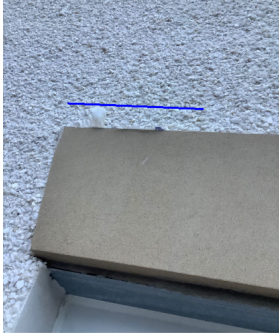
#### Defect 4

Priority: Medium  
Location: Front elevation

Description  
Trim plastic from top precast

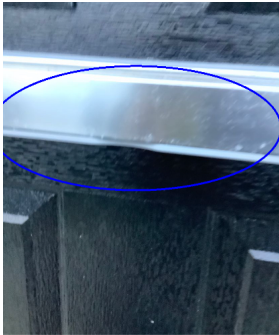
#### Defect 5

Priority: Medium  
Location: Front elevation

Description  
Letter box tarnished

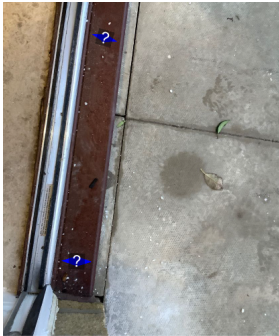
## Defect 6

Priority: Medium  
Location: Front elevation

External threshold running back towards front door and excessive movement and not sealed potential water ingress and drafts

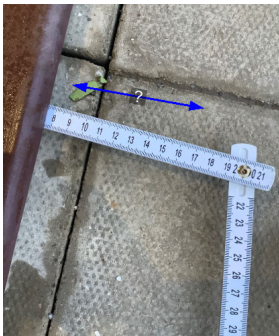
## Defect 7

Priority: Medium  
Location: Front elevation

Excessive gapping underside threshold and threshold not secured excessive movement
